# BLACKBOARD

## H<sub>2</sub>S-CORROSION - NOT WITH ROMOLD

## ROMOLD SOLUTION Nr. 2.1:

### Shaft-in-Shaft Renovation incl. chamber bottom

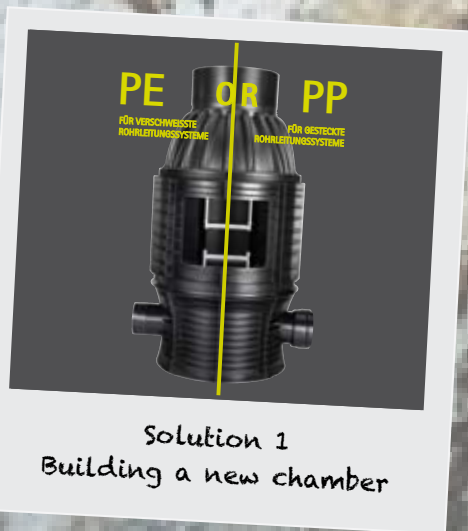
**Solution 1**  
Building a new chamber

The construction of a chamber usually represents the most expensive and most circumstantial form of the remedy of corroded chambers. With ROMOLD plastic chambers you can not only fix the problem, you can solve it. The reason is the 100% corrosion resistance and the associated 100-year lifetime of plastic chambers.

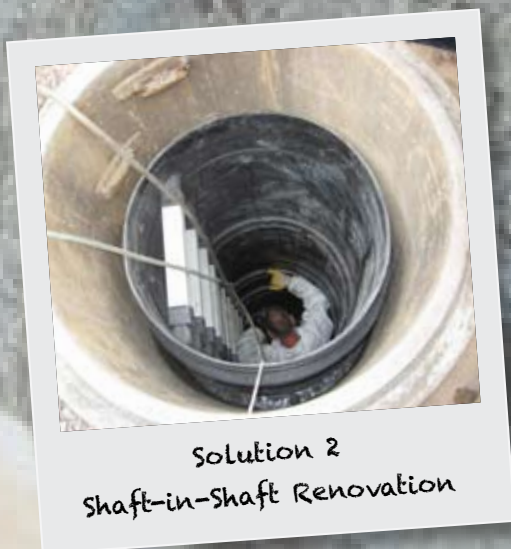
**Solution 2**  
Shaft-in-Shaft Renovation

The renovation is the lowest common compromise in most cases. Expensive, time-consuming and usually not associated with the planned service life. ROMOLD has also here a perfect solution. The renovation is done via the installation of a new ROMOLD chamber with reduced diameter within the old manhole.

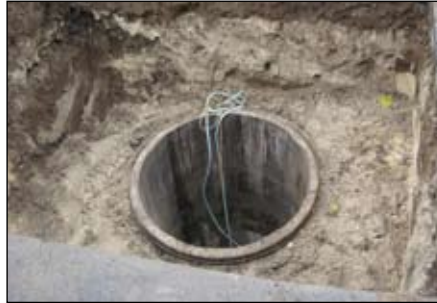
1.) Cut the asphalt, and lift the concrete cone

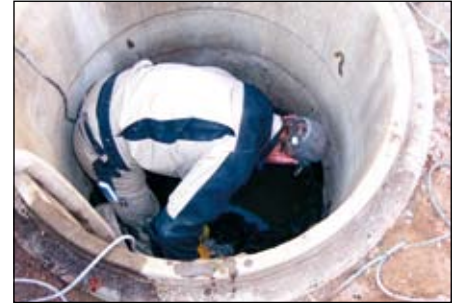
2.) Remove climbing steps, pry berm and flume, dewatering, set the over-pumping operation

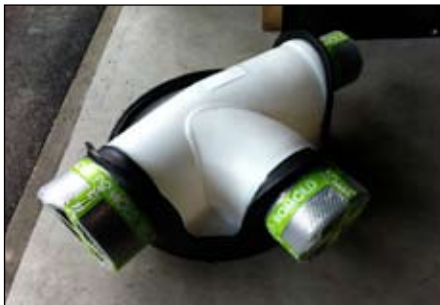
3.) Prefabricated channel with PE-socket

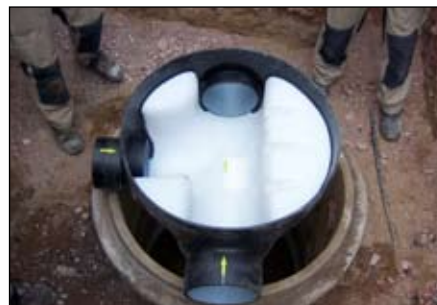
4.) Adapt the prefabricated channel with PE-socket

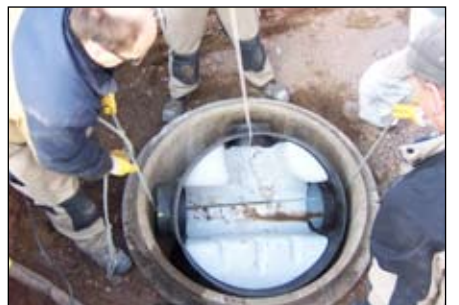
5.) Adapt the prefabricated channell with PE socket and place it into the chamber bottom

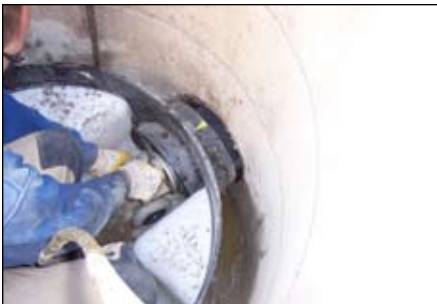
6.) Set the sealing plug to the in- and outlets, fill the gap with modified filling mortar

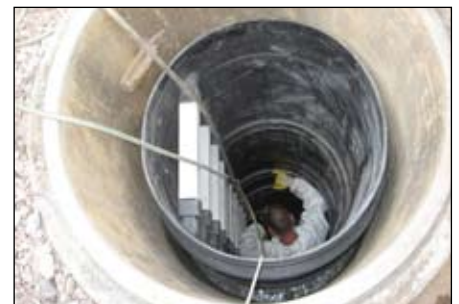
8.) Fitting the seals and chamber components - PE shaft system DN 800

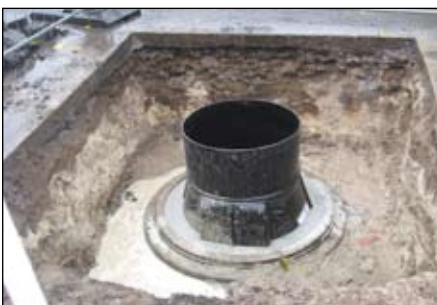
9.) Filling the gap between PE-chamber DN 800 and DN 1000 concrete manhole with filling mortar

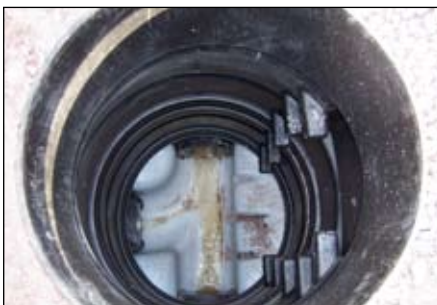
10.) Ready renovated manhole. Steps were removed on customer request

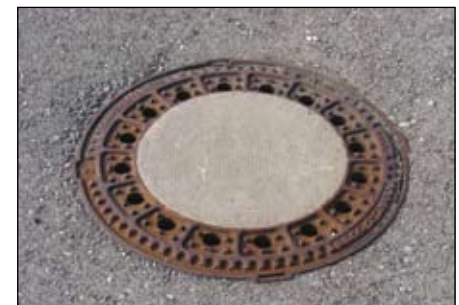
11.) Restoring of road construction incl. decoupled load cover

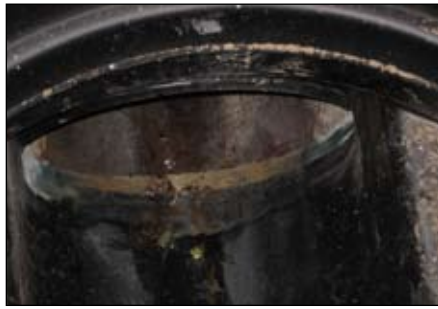
Connection of PE pipe in old pipe either by using Quicklock collar or with construction chemicals

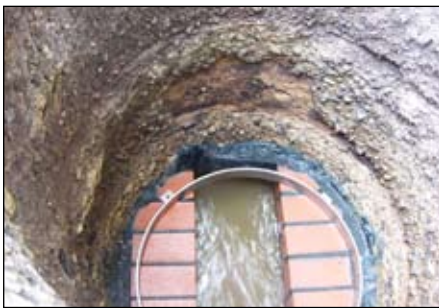
1.) Cut the asphalt, lift the concrete cone and fix the mounting ring on berm

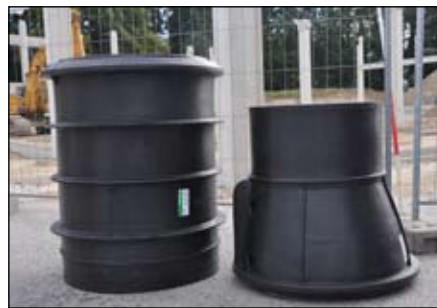
2.) ROMOLD DN 800 standard chamber components

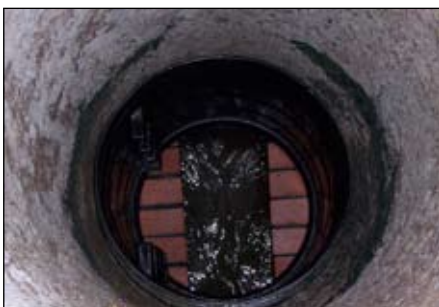
3.) Fitting the seals and chamber components - PE chamber system DN 800

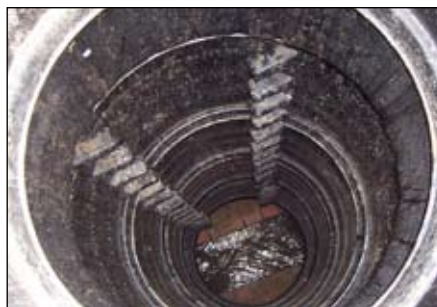
4.) Ready renovated manhole. Steps were removed on customer request

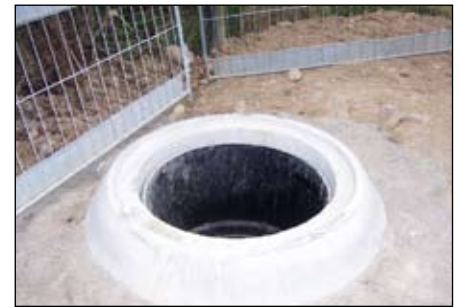
5.) Filling the gap. Restoring of road construction incl. decoupled load cover
